# Application of Terahertz Imaging and Backscatter Radiography to Space Shuttle Foam Inspection

Warren Ussery  
Lockheed Martin Space Systems Company  
504-257-1834  
[warren.ussery@maf.nasa.gov](mailto:warren.ussery@maf.nasa.gov)

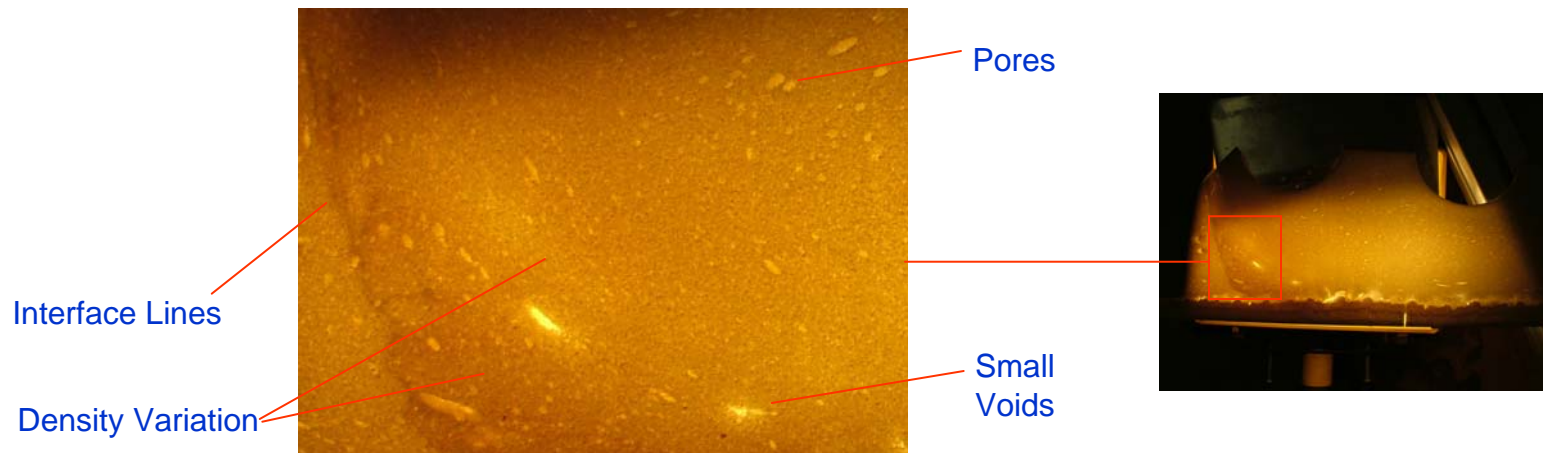
**Typical Slice of ET Foam (Backlit to Emphasize Density Variations and Voids)**

- **NDE Difficulties in Polyurethane Foam Inspection**
  - Does not lend itself to conventional NDE methods
  - Very low density (~2.5 lbs/cu ft) so air voids do not exhibit significant density change
  - Non homogeneous material with density variations
  - Inspection must be single sided due to access restrictions
  - No history of industrial inspection of foam
- **Conventional NDE Method Assessment**
  - UT: Foam attenuates UT
  - X-ray: Requires two sided access
  - Thermography: Foam is an insulator
  - Air-Coupled, Low Freq. UT: Non-homogeneous foam structure impairs technique

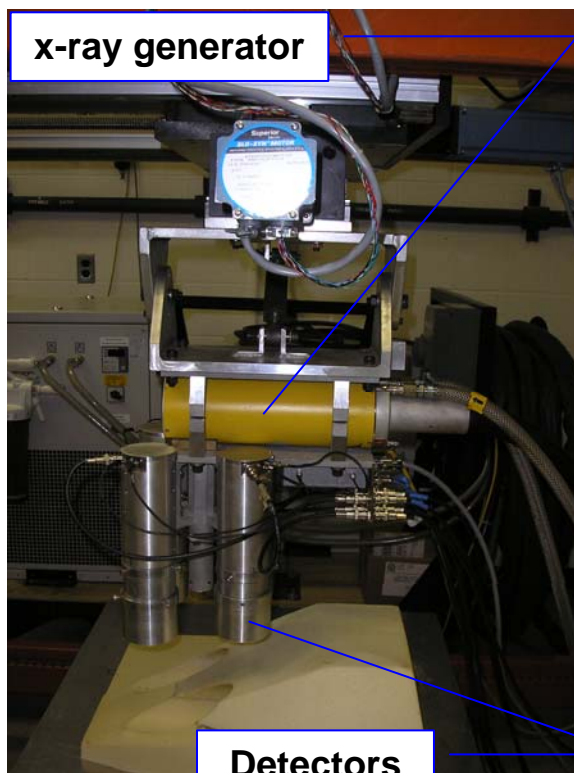
- Collimated beam of x-rays (55-70 kV) interact with sample molecules
- Backscatter x-rays are emitted (Compton Scattering), possibly after multiple subsequent scattering events, and detected by NaI or YSO detectors
- Collimation provides some preferential sensitivity to selected depth
- The x-ray beam and detectors are scanned across the part to generate a 2-D presentation of the internal make-up of the foam

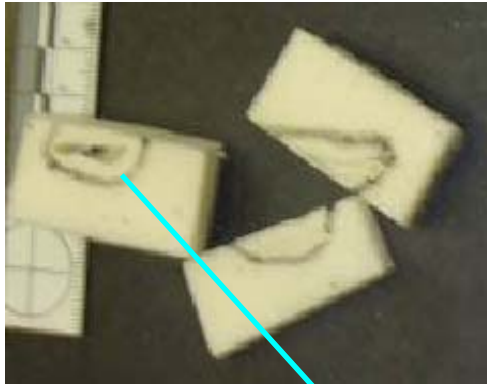
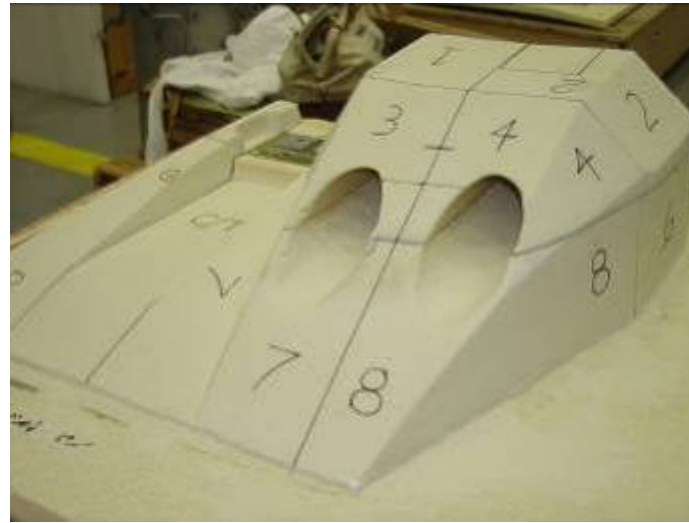
IFR test panel

## Examples of BSX Defect Indications

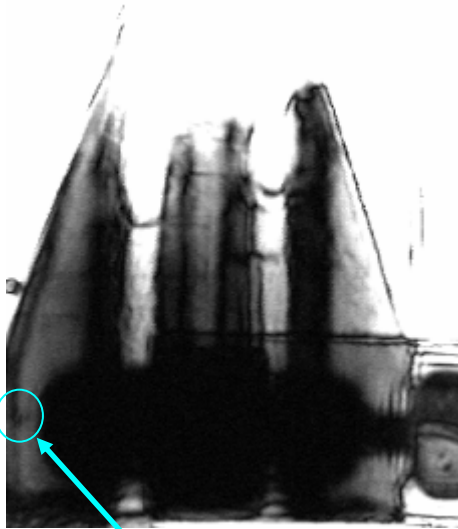
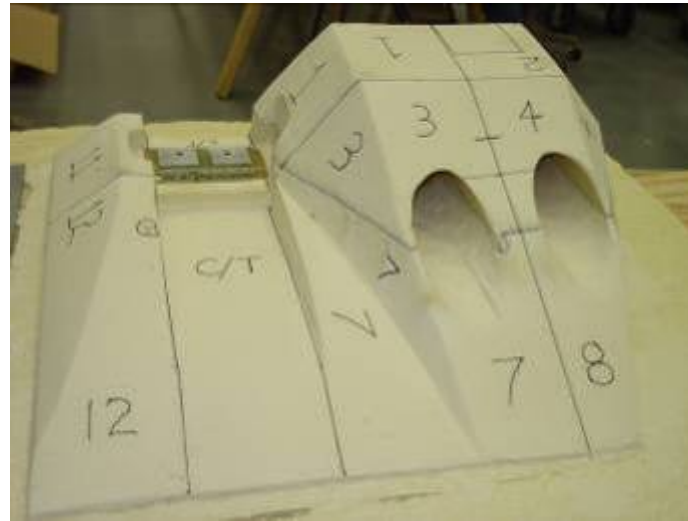
IFR test panel

## Examples of THZ Defect Indications

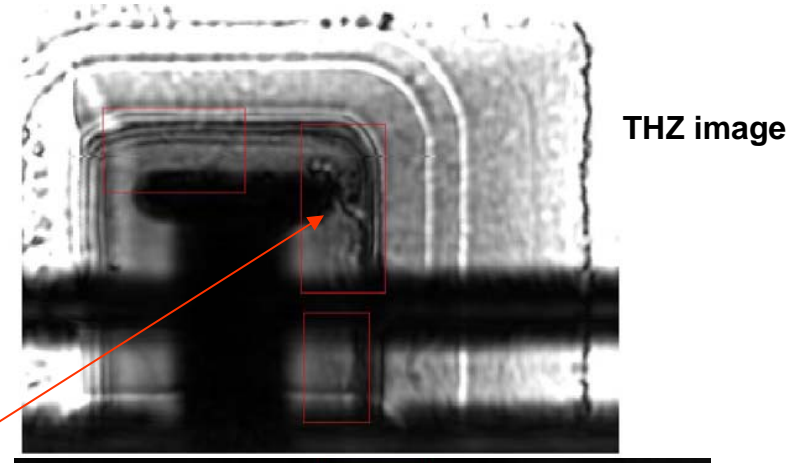
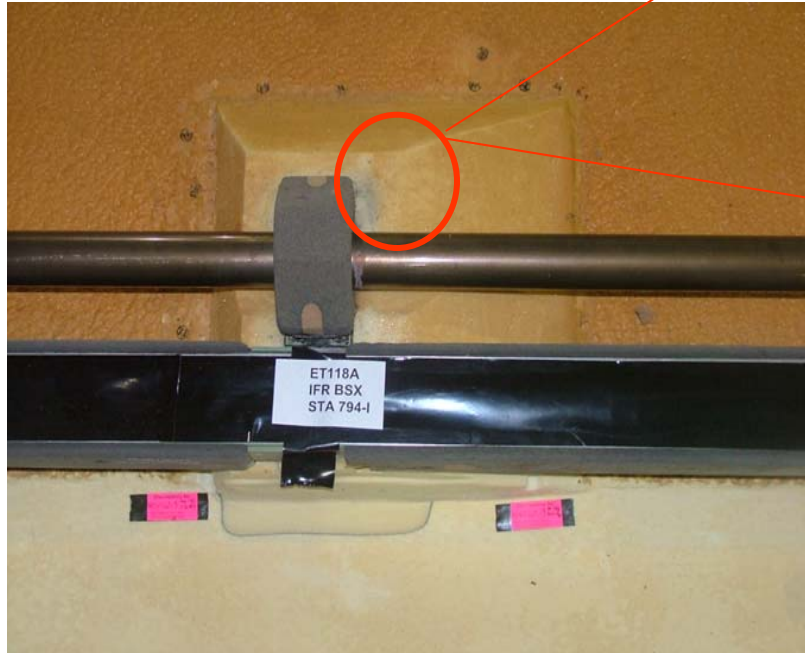
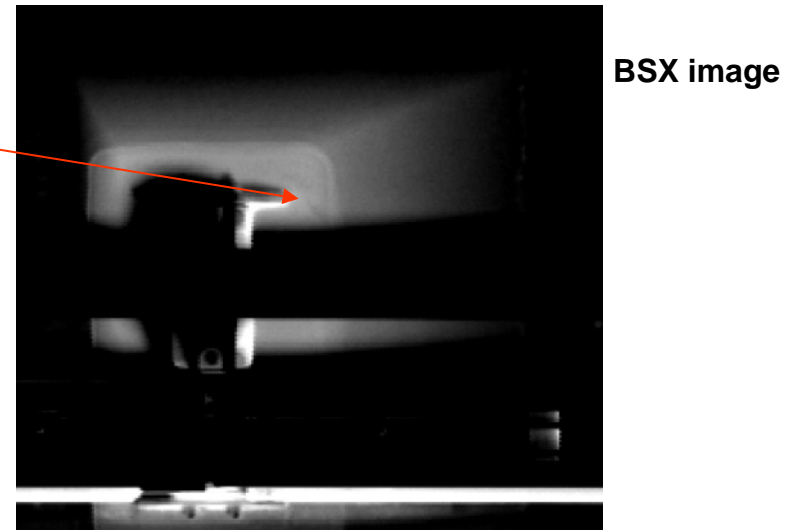
- **Example 1**
  - THZ image has distinct response from void
  - BSX image has marginal response from void

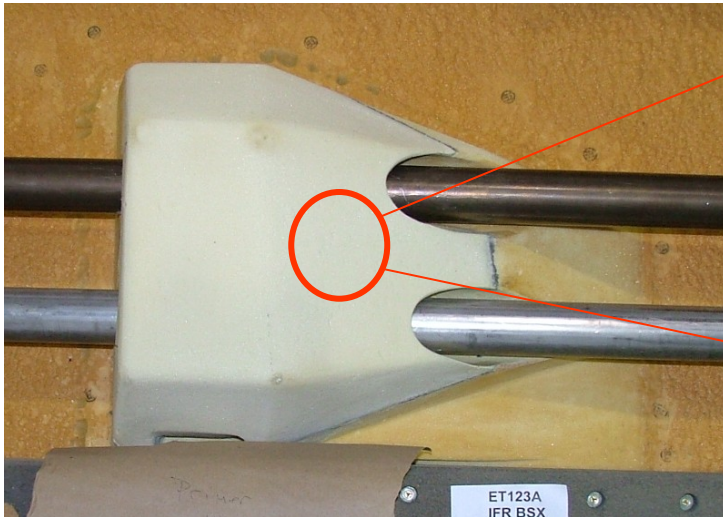
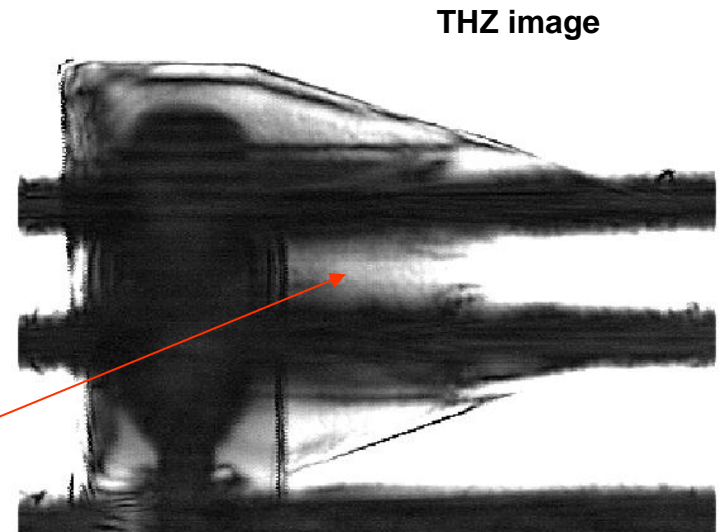
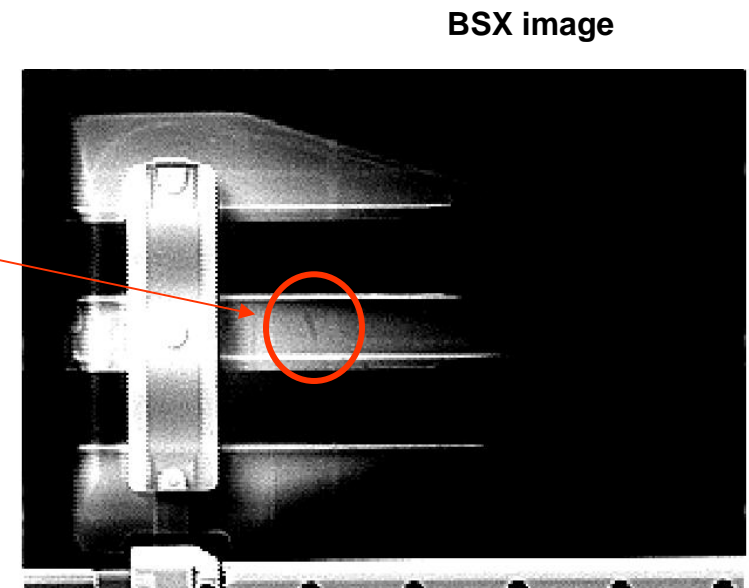
- **Example 2**
  - BSX image has distinct response from void
  - THZ image has marginal response from void

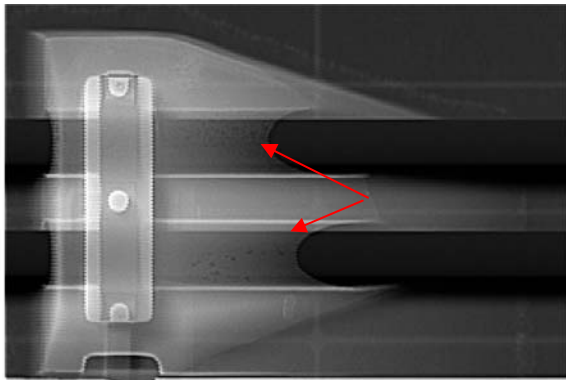
Porosity visible over press lines  
in BSX scans

- THZ scans are limited by substrate geometry
  - THZ is 'blinded' by irregular part geometry so no THZ data can be obtained in those regions
  - THZ is most effective in the first 3" to 4" of foam adjacent to the substrate, less effective at higher elevations above the substrate
- BSX provides
  - high spatial resolution
  - most effective near the part surface

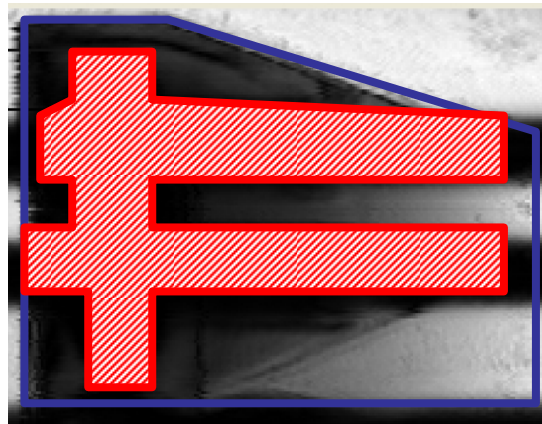
No information above irregular  
subsurface parts in THZ scans

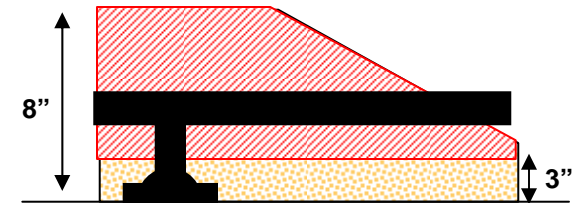
THZ resolution degrades in  
regions above the substrate

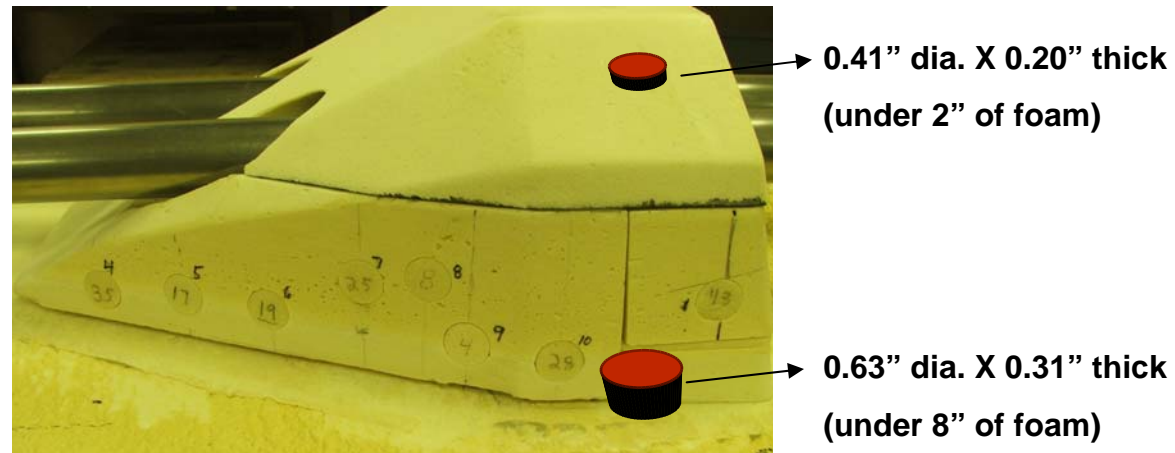
- **Detection Capability**
  - Probability of Detection Study
  - Based on combined result from both BSX and THZ inspections
  - Multivariate regression analysis
  - Samples consisted of 100 natural defects and 300 blanks
  - 90/95 detection capability established
  - Zero false calls

90/95 POD Results

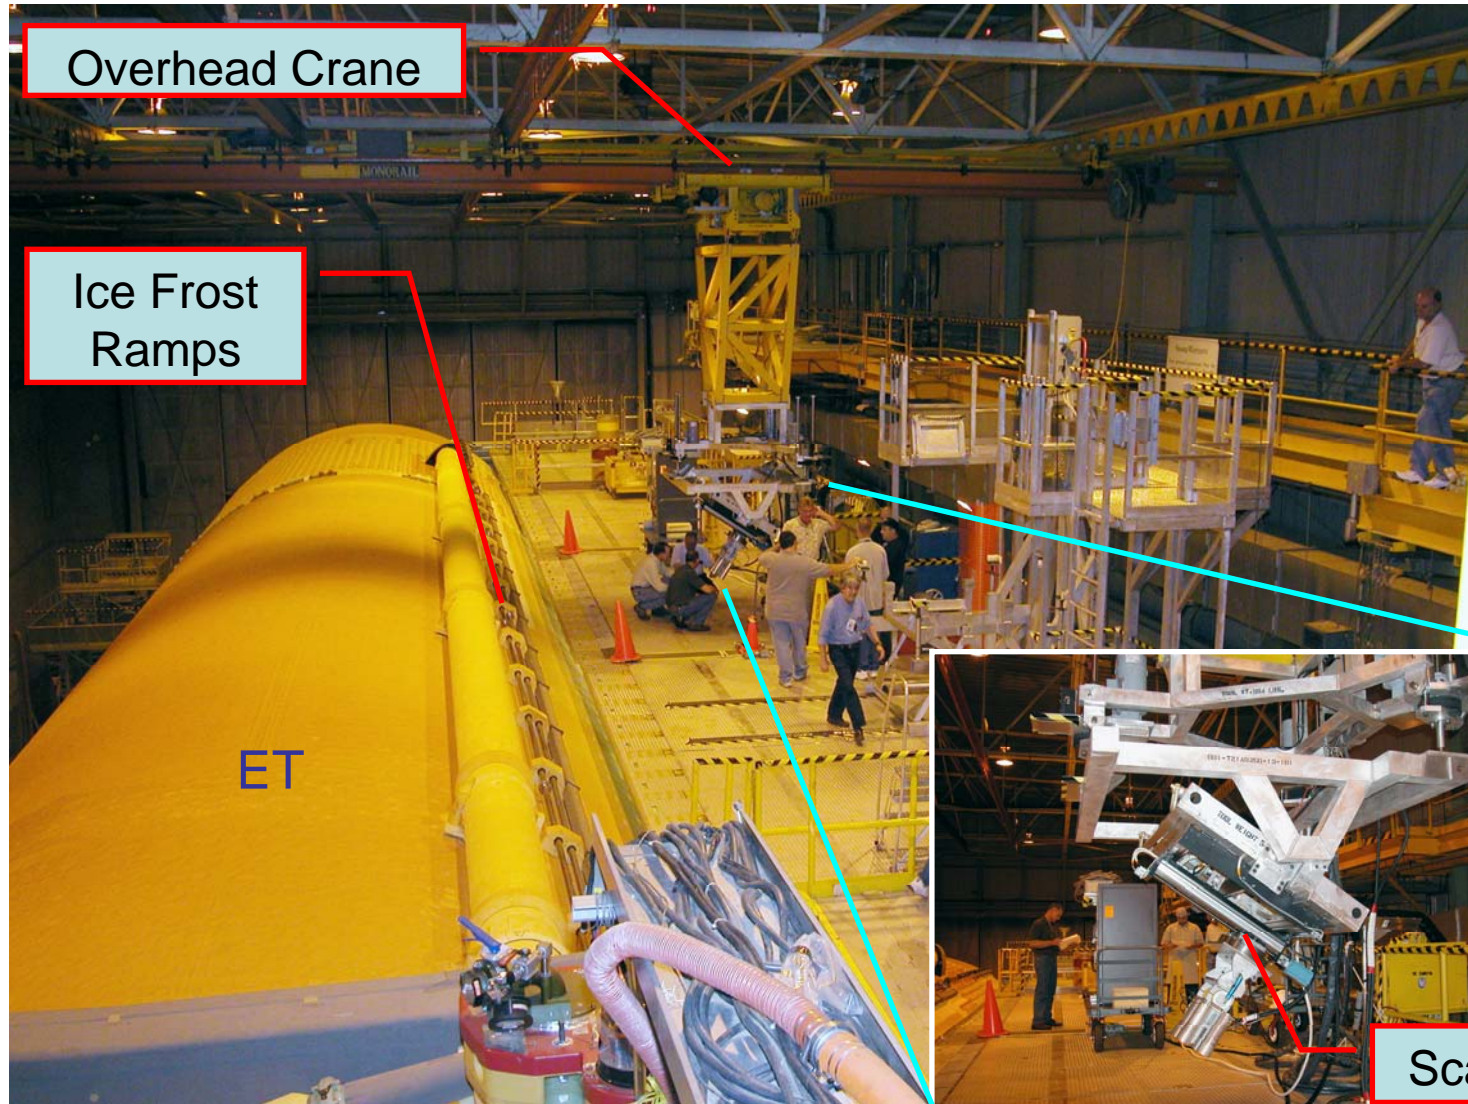
NDE Activity in Building 420 at the Michoud Assembly Facility
